LOUISIANA DEPARTMENT OF WILDLIFE & FISHERIES

WATERBODY MANAGEMENT PLAN SERIES

LAKE BISTINEAU

LAKE HISTORY & MANAGEMENT ISSUES

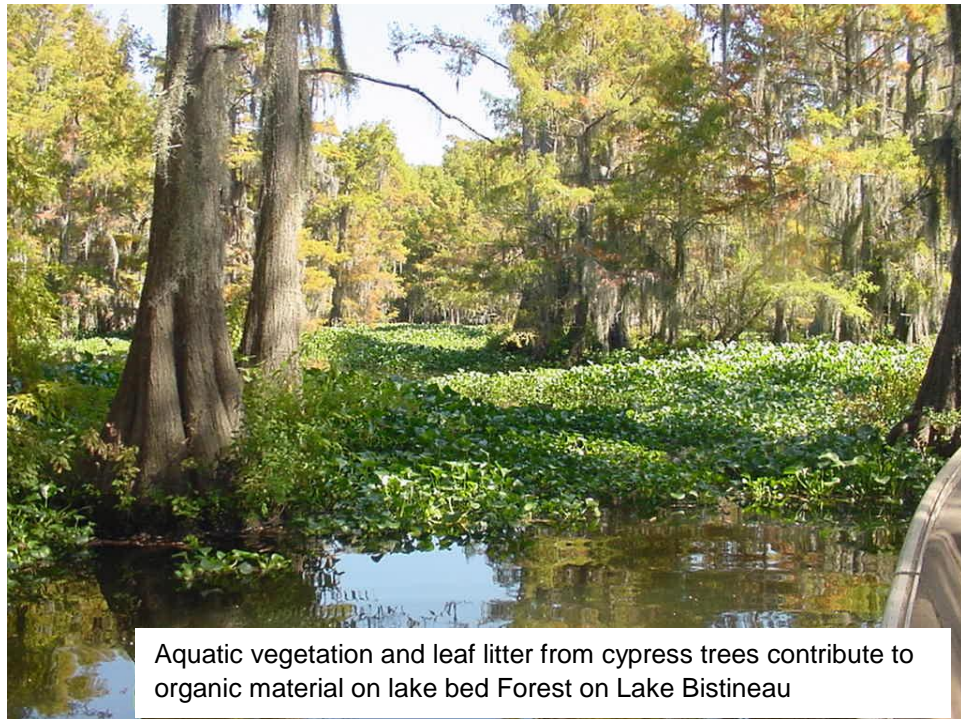
Aquatic vegetation and leaf litter from cypress trees contribute to organic material on lake bed Forest on Lake Bistineau

A series of mid-summer drawdowns were conducted during 2004 and 2005 to aid in reduction of the large amount of organic matter on the lake bed. Historically, Lake Bistineau has had heavy infestations of water hyacinth, alligator weed, and submersed native aquatic vegetation. The decay of these plants, along with leaf litter from the cypress canopy, has accumulated a large layer of organic matter on the lake bed. This problem is especially evident in the upper end of the lake and in cove areas. This deterioration of the aquatic habitat has resulted in the loss of spawning substrate for nesting sport fish species. A decline in the relative abundance of sport fisheries was observed during electrofishing sampling in the years preceding the lake drawdowns. The lake bottom condition was most impacted in the north end of the lake, with fish species composition changing from desirable sport fishes to less desirable species that thrive in shallow, weedy habitats. Examples include spotted gar, lake chubsuckers, and spotted suckers.

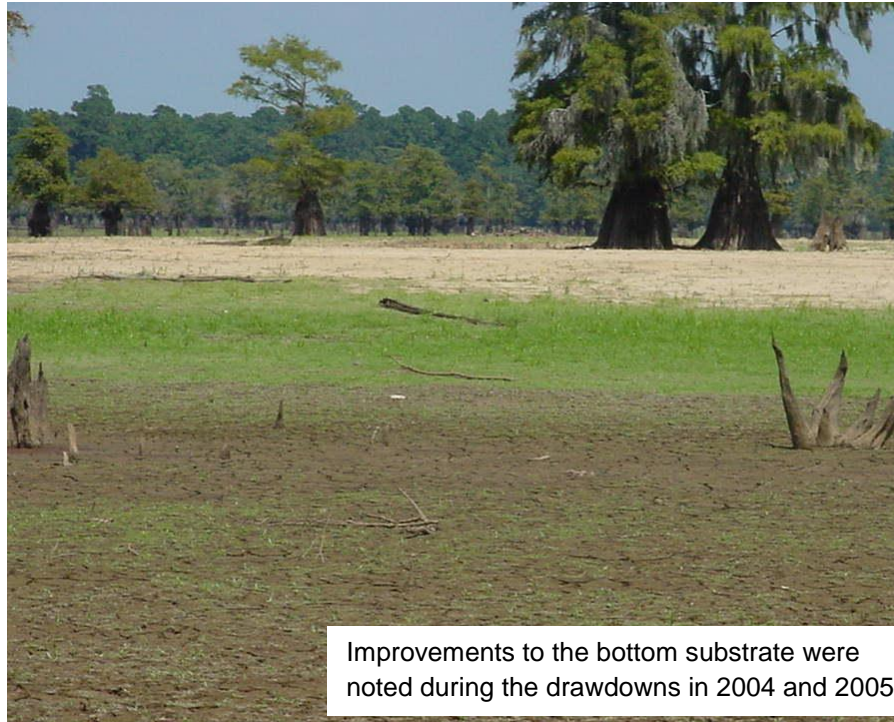
Improvements to the bottom substrate were noted during the drawdowns in 2004 and 2005

Significant improvements were made to the fisheries habitat of Lake Bistineau as a result of the two consecutive mid-summer through winter drawdowns during 2004 and 2005. Substantial reduction in the depth of organic material on the lake bed was noted in many areas that were exposed. Improvements to spawning substrate were also significant, with sand being exposed following the decomposition of the organic material. Sunfish responded well to the improved spawning habitat and anglers quickly took notice. Fishing activity on the lake increased from previous years. The drawdowns were also beneficial to the black bass population.

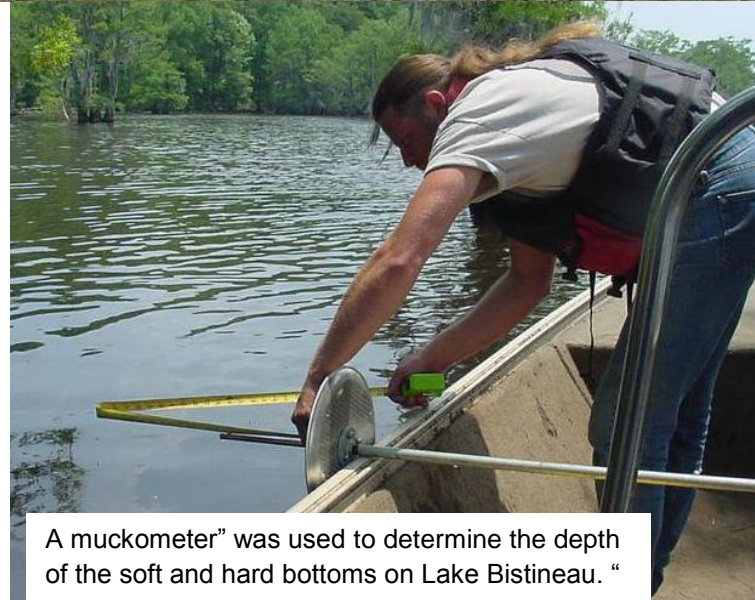
A muckometer” was used to determine the depth of the soft and hard bottoms on Lake Bistineau. “

Two methods were utilized to quantify the reduction in organic material. One method involved the use of an improvised device termed the “muckometer”. This device was used to differentiate between the soft and hard bottoms of the lake while the lake was at normal levels. A 12” diameter perforated aluminum disk was mounted on a length of pipe which served as a sleeve for a ½” metal rod which slid down to identify the hard bottom. This device was placed vertically in the water until the perforated disk contacted the soft bottom of the lake. The weight of the apparatus defined the depth of the soft bottom. A set screw was then loosened allow the ½ metal rod to slide freely within the sleeve. A pressure scale was then used to apply 10 lbs. of pressure to the top of the metal rod to force the rod through the soft organic material on the lake bed and stop at the hard bottom of the lake. The set screw was then tightened and physical measurement made of the length the rod was protruding past the disk. This roughly equates to the depth of the organic material at the sample site. Three measurements were made at each station.

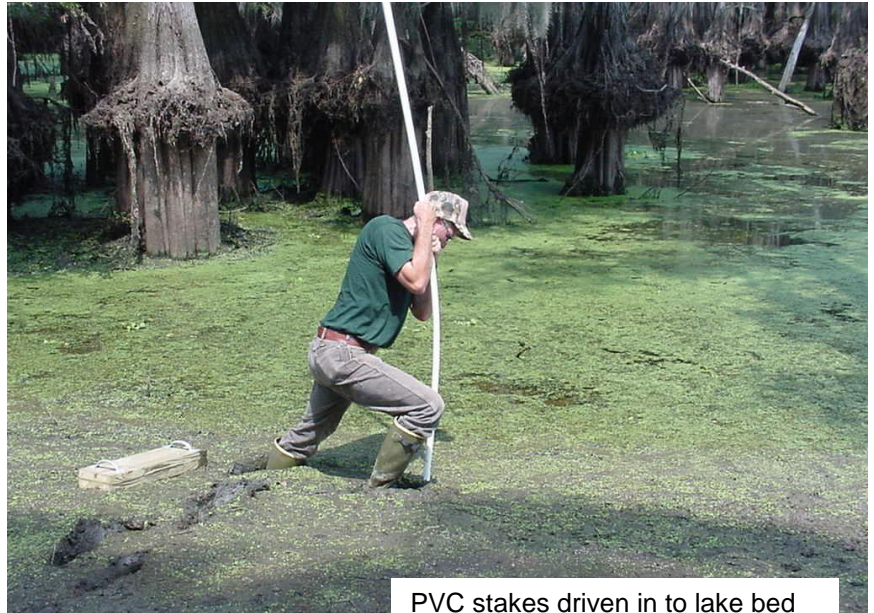
PVC stakes driven in to lake bed

The other method consisted of placing $\frac{3}{4}$ " PVC stakes in the lake bed during the initial dewatering process of the 2004 drawdown. Stakes were pushed into the lake bed and then hammered in further to the point of refusal of further penetration. The stakes were allowed to protrude 1.5" above the bottom substrate. After significant drying action occurred during the 2004 drawdown and in subsequent drawdowns, measurements of the height the stakes protruded above the bottom substrate were made. The difference in the height the stakes protrude above the lake bed roughly equates to the reduction in organic material on the lake bed at the site. Both methods indicate a significant reduction in organic material following the drawdowns.

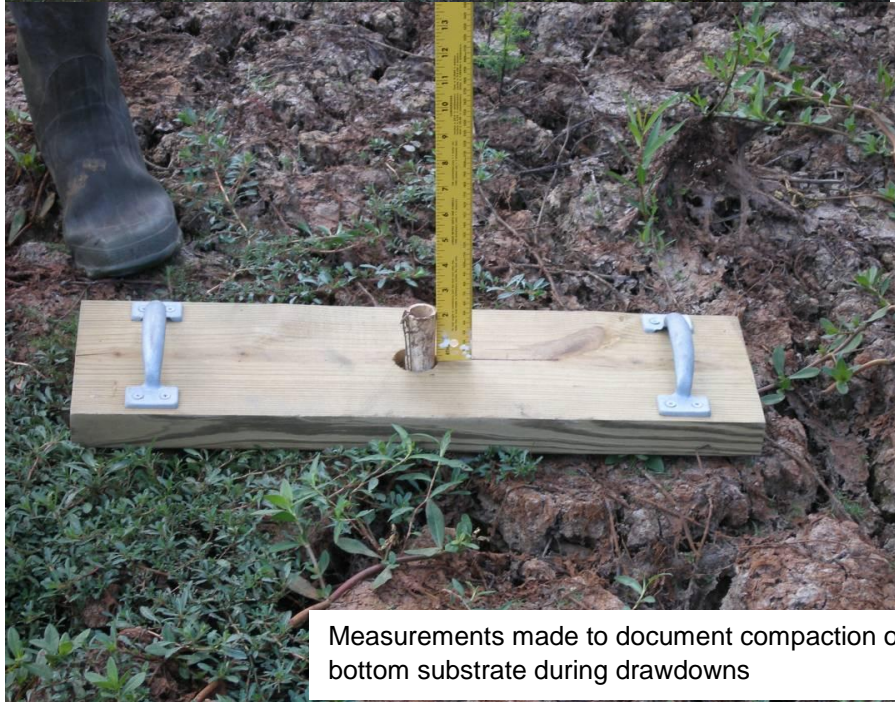
Measurements made to document compaction of bottom substrate during drawdowns

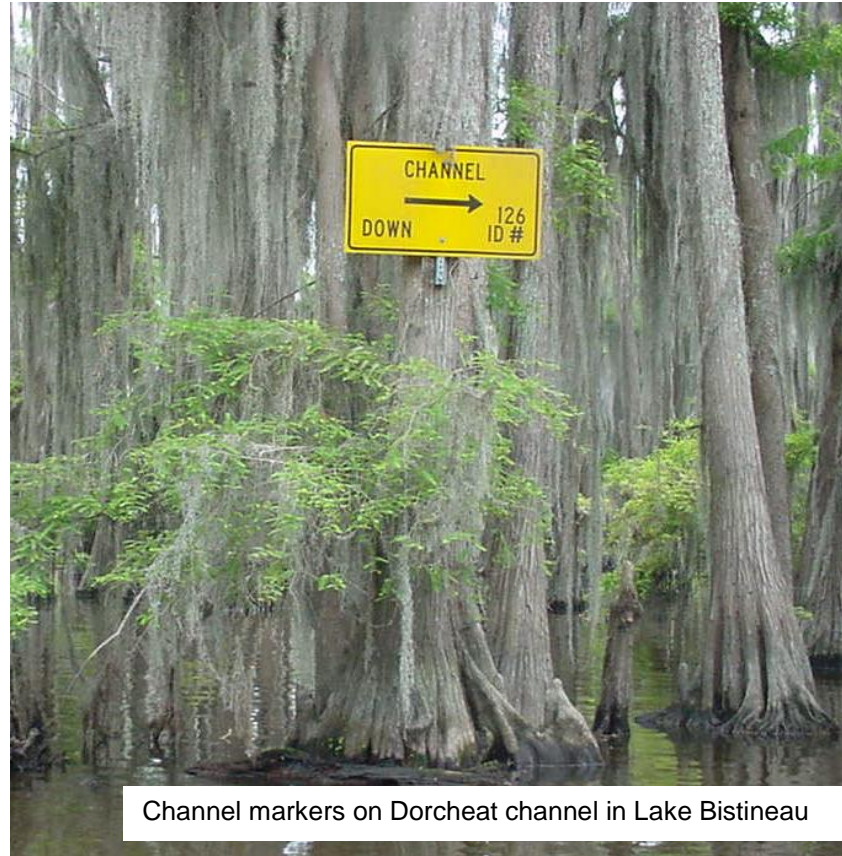
Channel markers on Dorcheat channel in Lake Bistineau

New channel markers were installed in 1993 by the Department of Transportation and Development with assistance from the Louisiana Department of Wildlife and Fisheries. In most areas of the lake, the signs marking the channel were attached directly to the cypress trees. In areas that lacked sufficient cypress trees, the metal signs were placed on pilings adjacent to the Bayou Dorcheat channel. Many of these metal signs have been compromised by the effects of wind and have fallen into the lake. There currently is a need to remark the main channel of the lake, replace signs that are missing, and trim cypress limbs that obscure signs attached to trees.

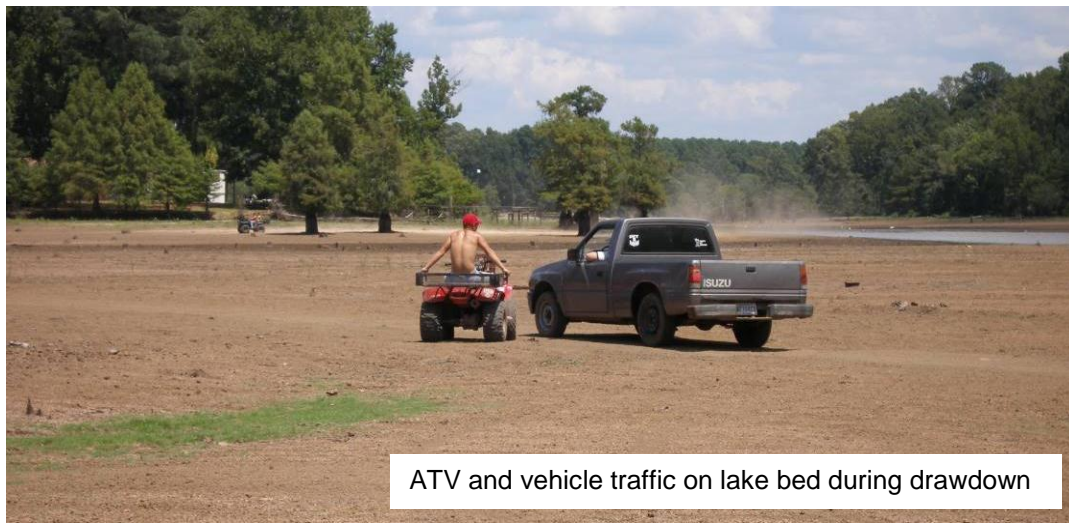
ATV and vehicle traffic on lake bed during drawdown

Several areas of Lake Bistineau dried out sufficiently during the drawdowns in 2004 and 2005 to allow for travel of all terrain vehicles (ATV’s) on the lake bed. Although some questions remain concerning legality of foot and vehicle traffic on the lake bed during drawdowns, ATV riding has become a very popular recreational activity during drawdowns. One launch facility on the northern end of the lake serves as an access point for many recreational ATV riders. The facility realizes increased revenues during these periods by charging an access fee.
